SERVICE BULLETIN

EC04-002

UNABLE TO MAINTAIN IDLE OR LOW/ROUGH IDLE AT START

APPLIED VEHICLES: 2002-03 Sentra (B15)
2002-03 Altima (L31)

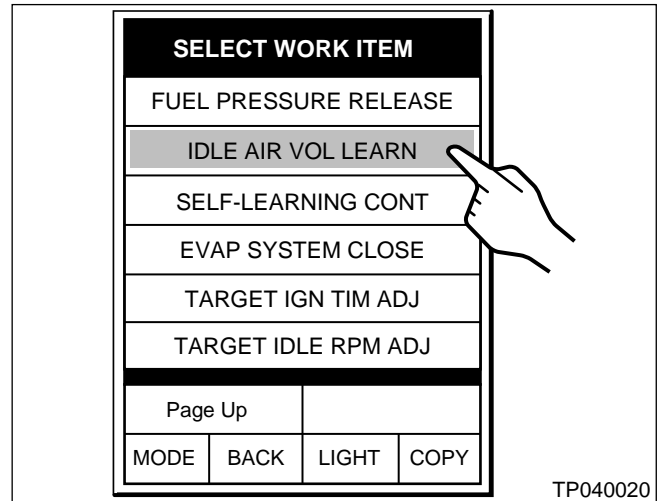
Figure 1

7. Connect CONSULT-II to the vehicle.
8. In the **CONSULT WORK SUPPORT** mode, select **IDLE AIR VOL LEARN**. See Figure 1.

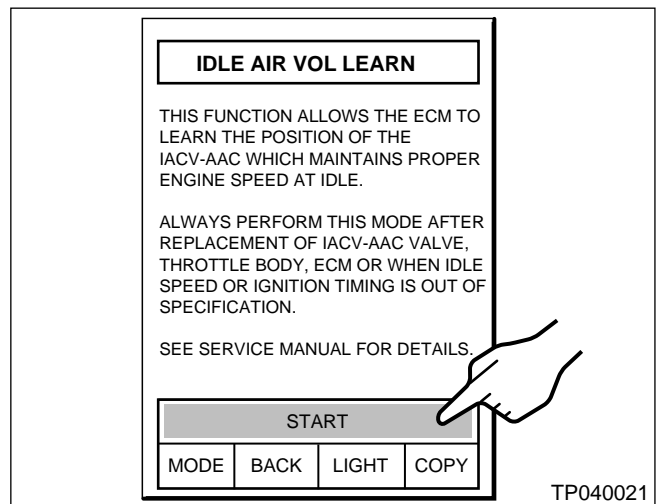
Figure 2

9. Press **START** on the "IDLE AIR VOL LEARN" screen. See Figure 2.

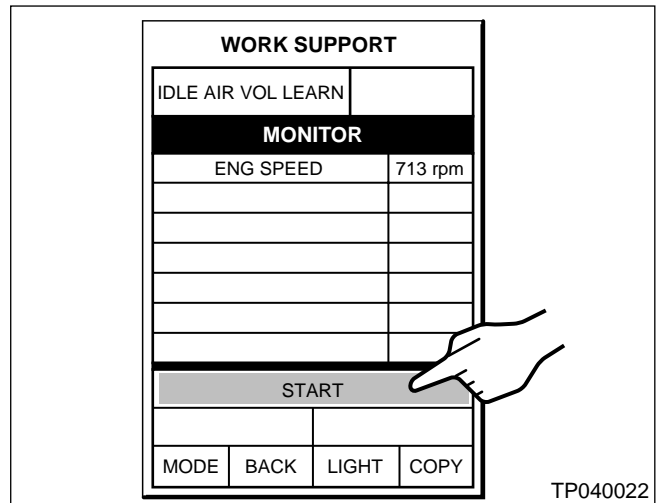
Figure 3

10. Press **START** on the “WORK SUPPORT” screen to begin the Idle Air Volume Learning (IAVL) procedure. See Figure 3.

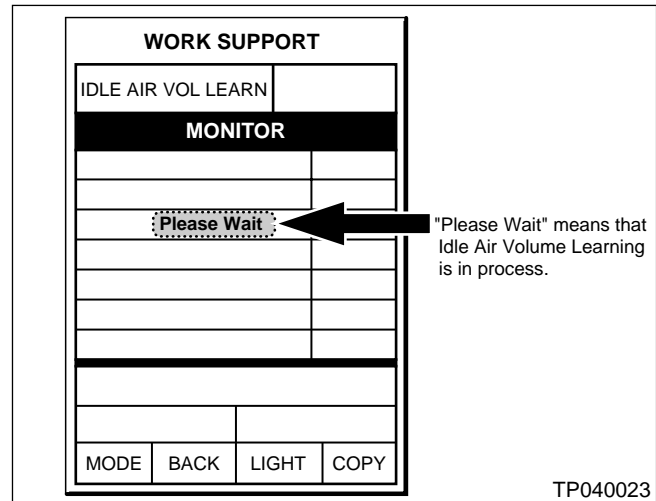
Figure 4

- The IAVL procedure will take several minutes to complete
- CONSULT will display “Please Wait” in the center of the screen while the IAVL procedure is in process. See Figure 4.
- CONSULT will display “CMPLT” in the top right corner of the screen when the IAVL procedure is finished. See Figure 5.
- If the IAVL procedure does not finish (“CMPLT”), perform the “**Corrected Idle RPM Check**” procedure starting on page 5. Then repeat steps 8 through 10 of the IAVL procedure.

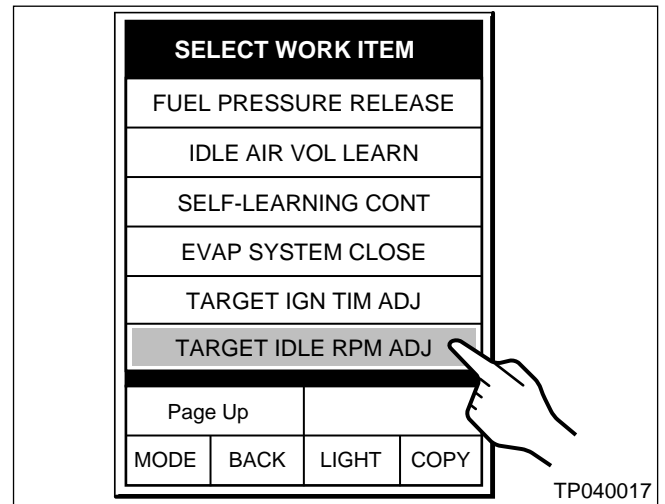
Figure 6

1. In the **CONSULT WORK SUPPORT** mode, select **TARGET IDLE RPM ADJ.** See Figure 6.

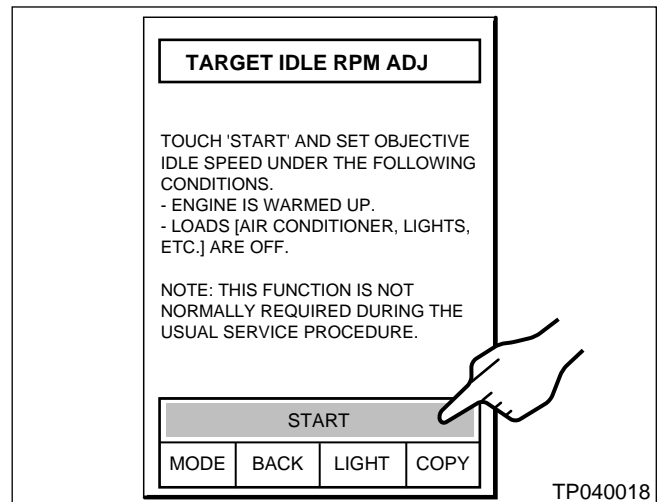
Figure 7

2. Press **START** on the “TARGET IDLE RPM ADJ” screen. See Figure 7.

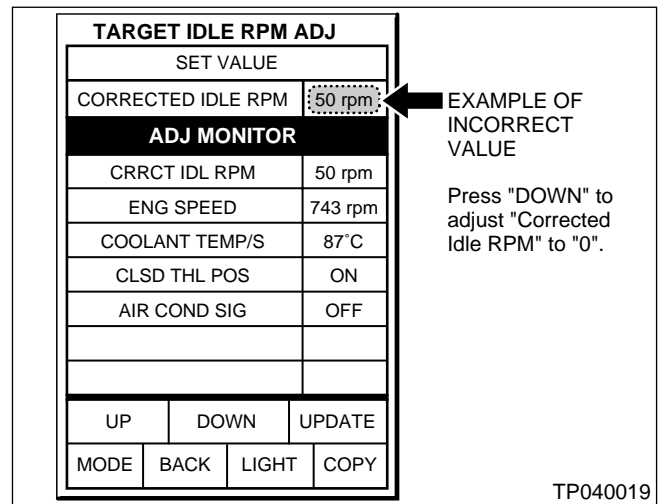
Figure 8

3. Check the CORRECTED IDLE RPM (see Figure 8):

- a. If the CORRECTED IDLE RPM is “0” (zero), press **BACK** two times, then perform the “Idle Air Volume Learning” (IAVL) procedure starting on page 3.
- b. If the CORRECTED IDLE RPM is NOT “0” (zero):
 - adjust the value to “0” (zero) using the **DOWN** key
 - press **UPDATE**
 - press **BACK** two times
 - perform the IAVL procedure starting on page 3.

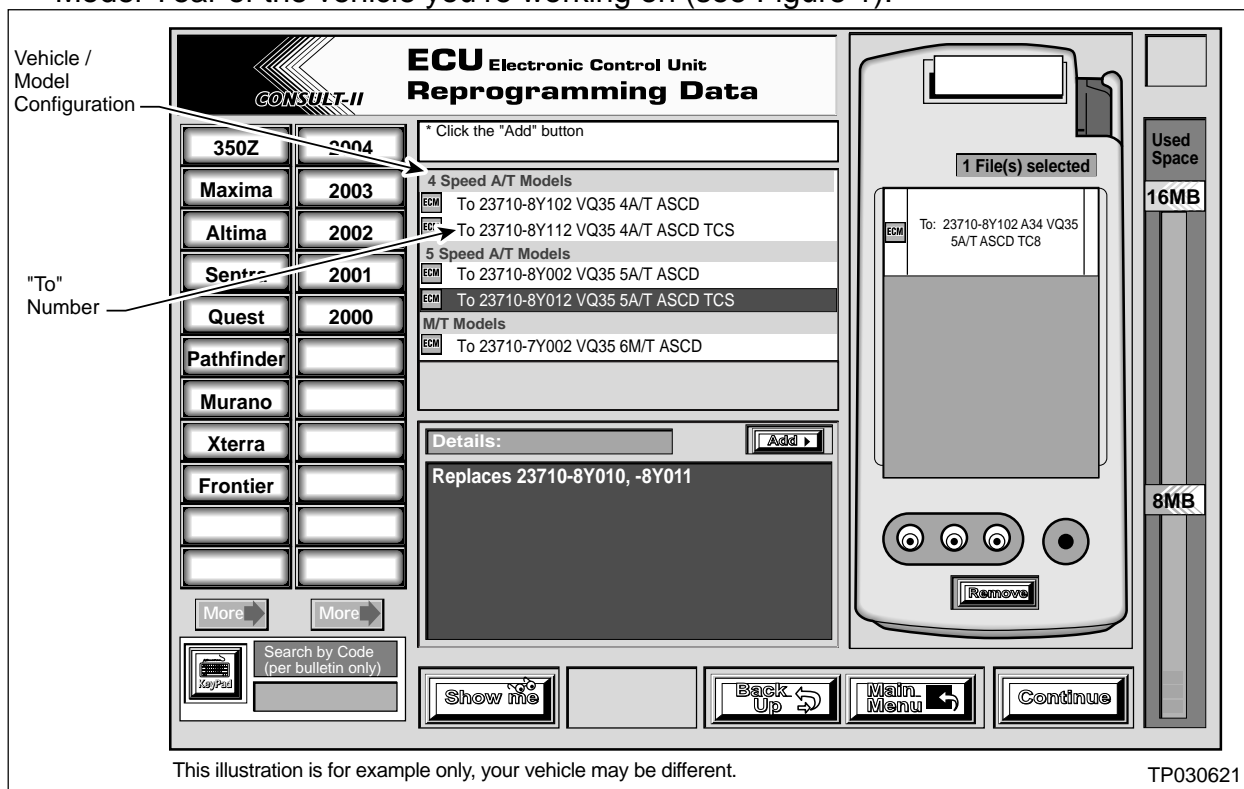
Figure 1

B. Go to ASIST: Select CONSULT Utilities > ECM/TCM Data. Then choose Model and Model Year of the vehicle you’re working on (see Figure 1).

C. Select the “configuration” on the screen for the vehicle you’re working on. Then **make sure** that your current ECM P/N is listed in the “Replaces 23710-XXXXX, -XXXXX, etc” section in the lower, center “Details” panel of the ASIST screen (see Figure 1).

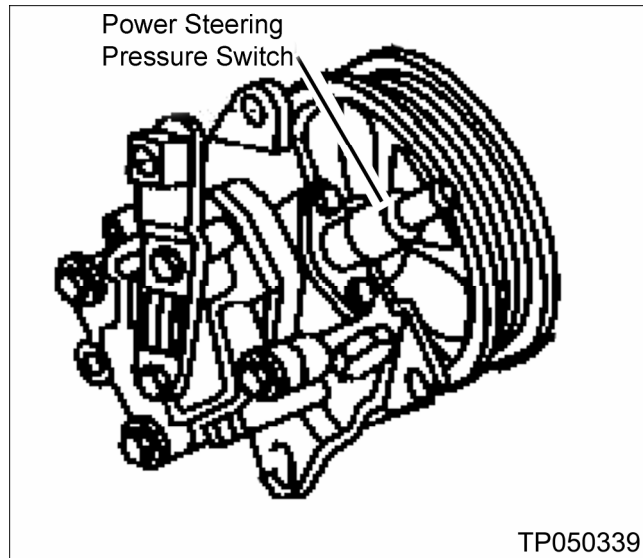
- The engine idle speed is typically between 1000 and 1500 rpm **when**
- the engine is at a normal operating temperature and
- the transmission is in either the “Park” or “Neutral” position and
- there are no DTC stored and
- the power steering pressure switch is “ON” when the steering wheel is straight ahead.

Replace the power steering pressure switch.
